**Docket No. 217 – Development and Management Plan Inspection**

Northeast Utilities Service Company Certificate of Environmental Compatibility and Public Need for the construction of a 345-kV electric transmission line and reconstruction of an existing 115-kV electric transmission line between Connecticut Light and Power Company's Plumtree Substation in Bethel, through the towns of Redding, Weston, and Wilton, and to the Norwalk Substation in Norwalk, Connecticut.

**Date:** April 12, 2006

**Location:** Overhead Line (Composite 345kV and 115kV Gallows Hill to Archers Lane, 345kV H-Frame Hoyts Hill to Gallows Hill, and Norwalk Section)

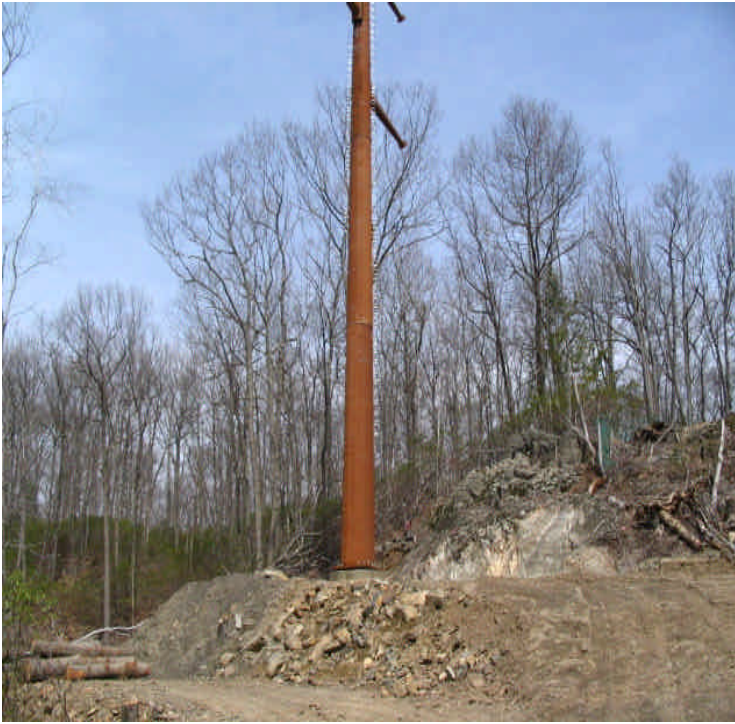
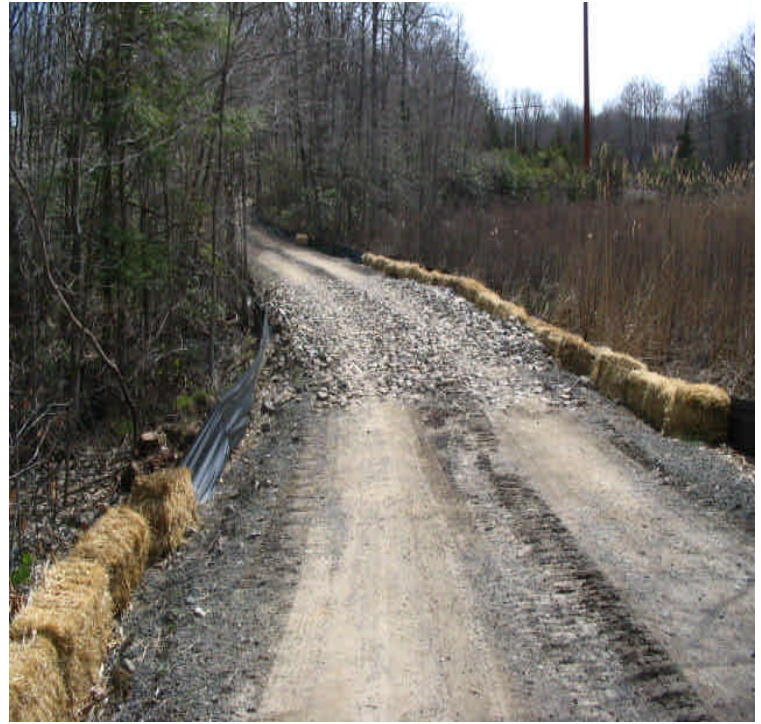
**(Composite Section-Archers Lane):** Photo on the left shows a view of the newly installed structure adjacent to the Archers Lane station pad. Photo on the right shows a view of the 2nd wetland crossing where some sediment has been removed. Erosion controls are still functioning well here. 4/12/06

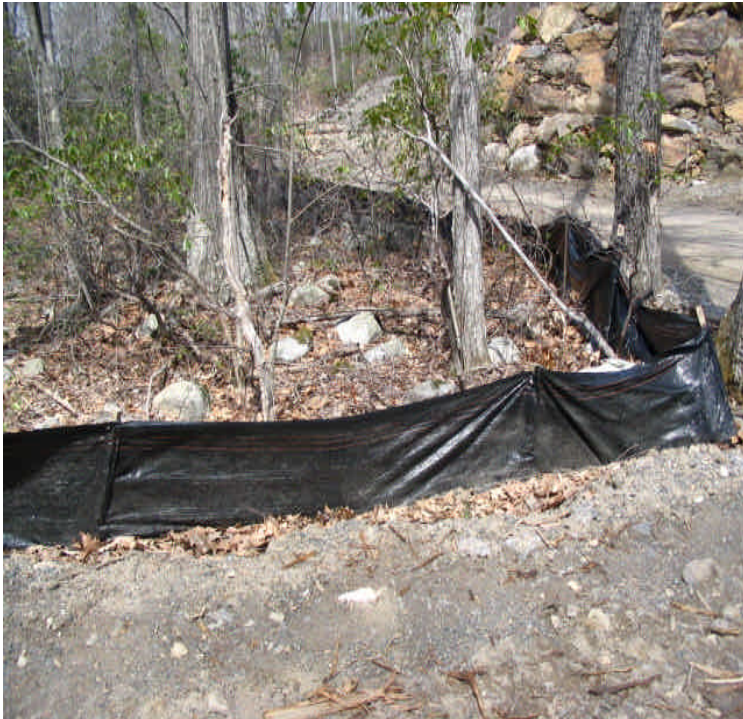
<p>Erosion and Sediment Controls</p> <p><b>Composite</b></p>	<p>- Water levels appear to remain low at the 2<sup>nd</sup> wetland crossing along the Archers Lane access road. 2/16-4/12/06.</p> <p>-The erosion controls at near the first turn at the first tower have been repaired. 4/12/06.</p>	<p>- None at this time. 4/12/06.</p> <p>-None at this time. 4/12/06.</p>	<p>-N/A</p> <p>-Erosion controls have been repaired here.</p>

Photo on the left shows a view the repaired silt fence near the turn off to the first tower from Archers Lane. Photo on the right shows the skidder damage remaining in the wetland at the 3<sup>rd</sup> crossing past Archers Lane. 4/12/06.

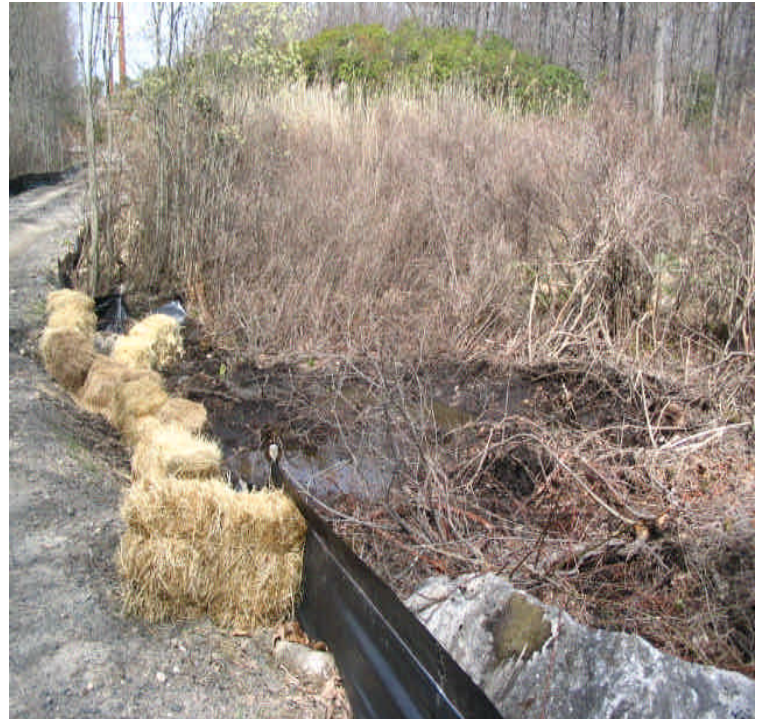
Areas of Inspection	Observation	Recommended Action	Corrective Action
Erosion controls continued	<ul style="list-style-type: none"> <li>- A skidder had slipped off the road into the 3<sup>rd</sup> wetland area. Haybales had been placed but ruts in the wetland remain. 3/2-4/12/06.</li> <li>- Efforts are being made to remove sediment accumulation near the Archers Lane area wetlands. 4/6-4/12/06.</li> <li>- Wood chips had been blown into the uplands and wetland area at the third structure in from Gallows Hill Road. 2/22-4/12/06. Another area with deep wood chips off the cleared ROW remains past Archers Lane. 3/15-4/12/06</li> <li>- Controls remain in good shape at the wetland at the 2<sup>nd</sup> structure off Gallows Hill. 4/6-4/12/06.</li> </ul>	<ul style="list-style-type: none"> <li>- Damage to the wetland should be repaired. 2/16-4/12/06.</li> <li>- In areas where sediment is substantial and feasibly removable, contractors will continue to take it out carefully by hand. 4/12/06.</li> <li>- Make sure chips stay on the ROW. Contractors to should remove the off ROW chips since this is not allowed in the D&amp;M plan. 2/22-4/12/06.</li> <li>- Wood chips on the ROW can remain at a depth of 3". Deeper piles should be spread out. 4/6-4/12/06</li> <li>- None at this time. Continue to monitor and keep activity out of the various wetland habitats as feasible. 4/12/06.</li> </ul>	<ul style="list-style-type: none"> <li>- Efforts to remove sediment are underway</li> <li>- CL&amp;P is looking into a solution here.</li> </ul>

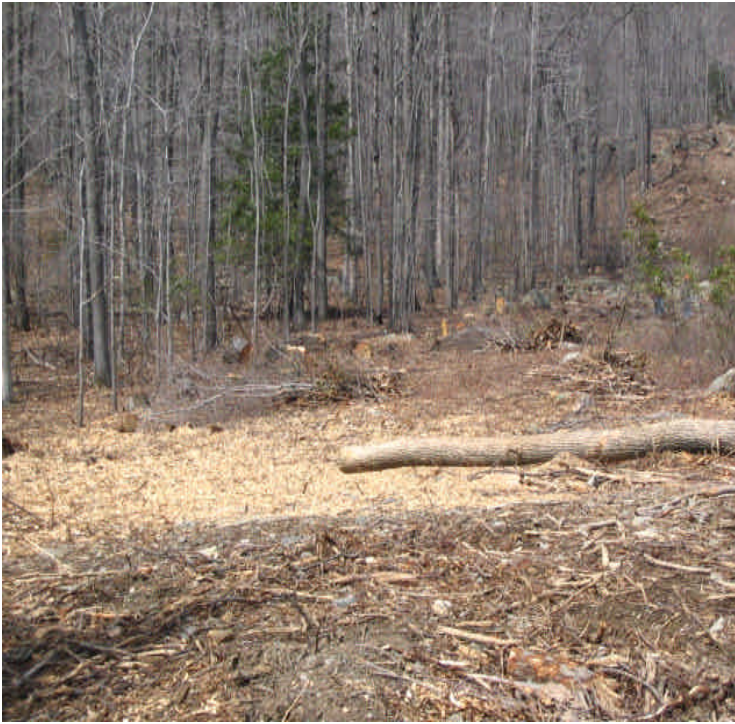
Vegetative clearing limits (including trees to save or danger trees noted)	<p>-Clearing had been noted in the composite section near Gallows Hill Rd. This includes work in wetlands. Adjacent homeowners mentioned damage to mountain laurel and other shrubs. 3/2-4/12/06.</p> <p>-An effort has been made to remove large branches and excess brush in the upland area of ROW between the 2<sup>nd</sup> and 3<sup>rd</sup> structure off Gallows Hill. 4/12/06.</p>	<p>-In general, take care in retaining shrubs and use mats to access or skid out trees from wetlands. 2/22-4/12/06.</p> <p>-Replace shrubs where necessary. 4/12/06</p> <p>-Continue to clear excess branches and brush from the upland portions of the ROW. Limbs and debris can remain in the wetland as well as within a "buffer" of ~30 feet on</p>	<p>-Large branches and brush have been piled for removal from the upland area of ROW between the 2<sup>nd</sup> and 3<sup>rd</sup> structure off Gallows Hill.</p>

**(Composite Section-Gallows Hill and 345kV H-Frame):** Photo on the left shows the ROW area between the 2nd and 3rd structures off GH where efforts are being made to remove branches and brush. Photo on the right shows near structure #19 where poles have been placed for installation. Due to the topography and small work area, poles have been placed outside the silt fence, adjacent to the wetland. 4/12/06.

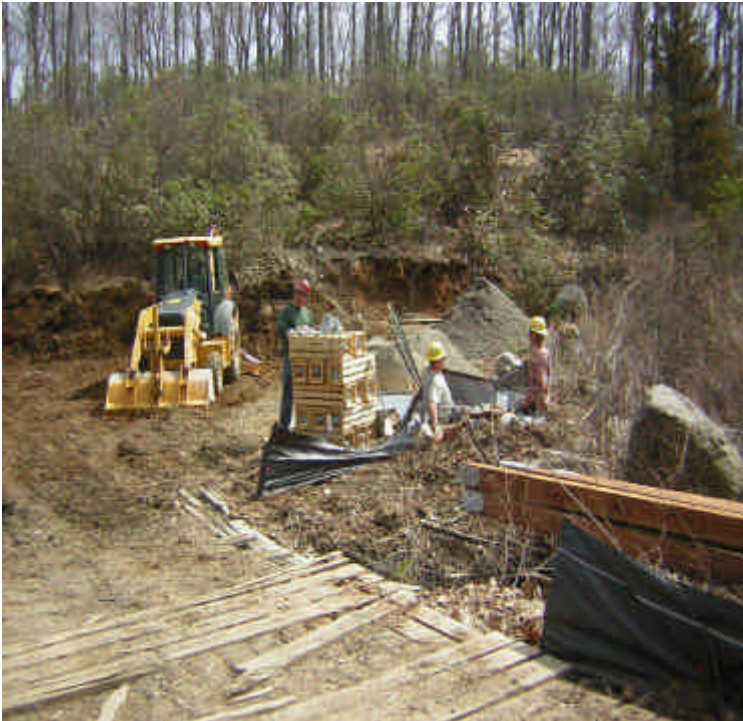
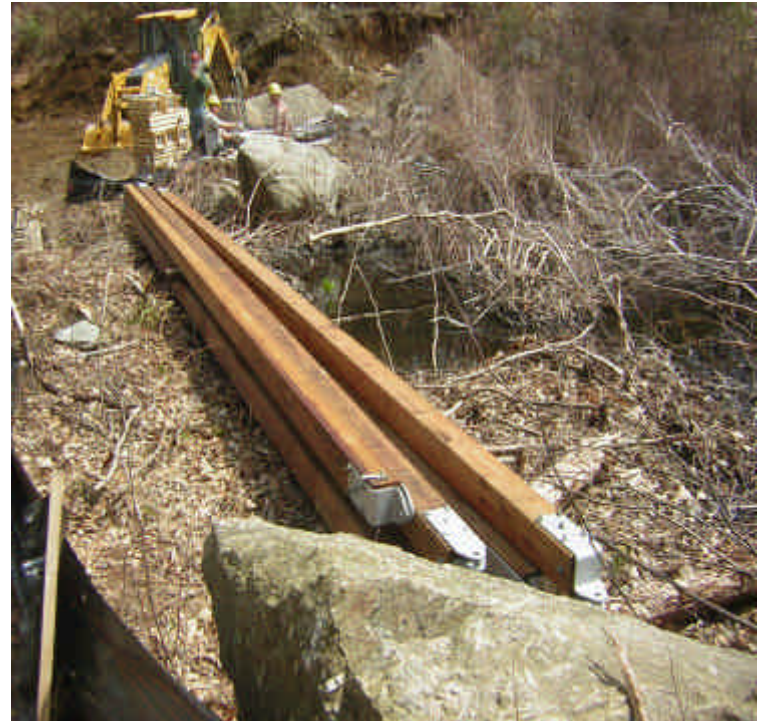
**(345kV H-Frame)** Photo on the left shows silt fence repairs and an overall view of the preparation work for installation of pole #19. Photo on the right shows pole components being stored in the wetland at this side as well. 4/12/06.

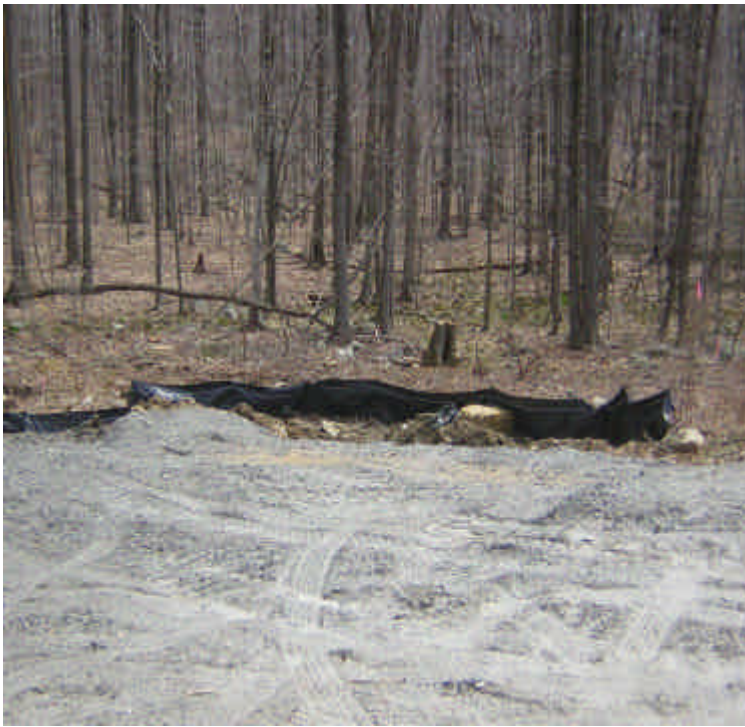
345kV H-Frame Chestnut Ridge Section	<ul style="list-style-type: none"> <li>- The majority of the pile at structure#6 has been removed. 4/12/06.</li> <li>- The stockpile near structure #9 has been removed, but the silt fence should remain maintained in this area. 4/6-4/12/06.</li> <li>- Silt fence and mats remain in place in a number of locations in this section. 4/6-4/12/06.</li> </ul>	<ul style="list-style-type: none"> <li>- Remove the soil here as soon as conditions can support this without further impact. 2/22-4/12/06.</li> <li>- Continue to monitor and maintain silt fence here until the area is stabilized. 4/6-4/12/06.</li> <li>- Continue to monitor for any muddy conditions or need for repairs. All observed controls remain in good condition. 4/6-4/12/06.</li> </ul>	<ul style="list-style-type: none"> <li>-N/A.</li> <li>-N/A</li> </ul>
Bethel Reservoir Section to

**(345kV H-Frame Chestnut Ridge Section) Photo on the left shows a view of the remaining soil at pole #6. Photo on the right shows a view of pole #1 where crews were preparing the area for installation. 4/12/06.**

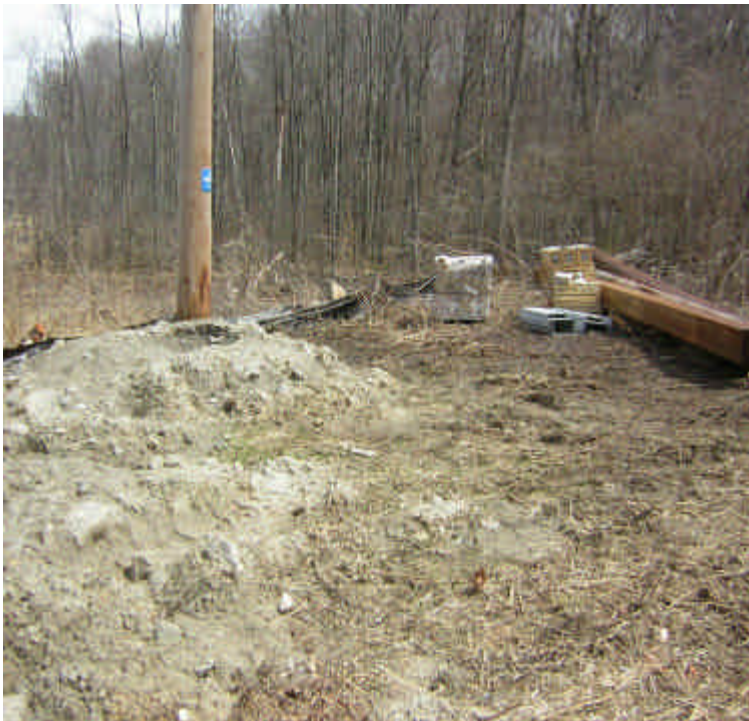
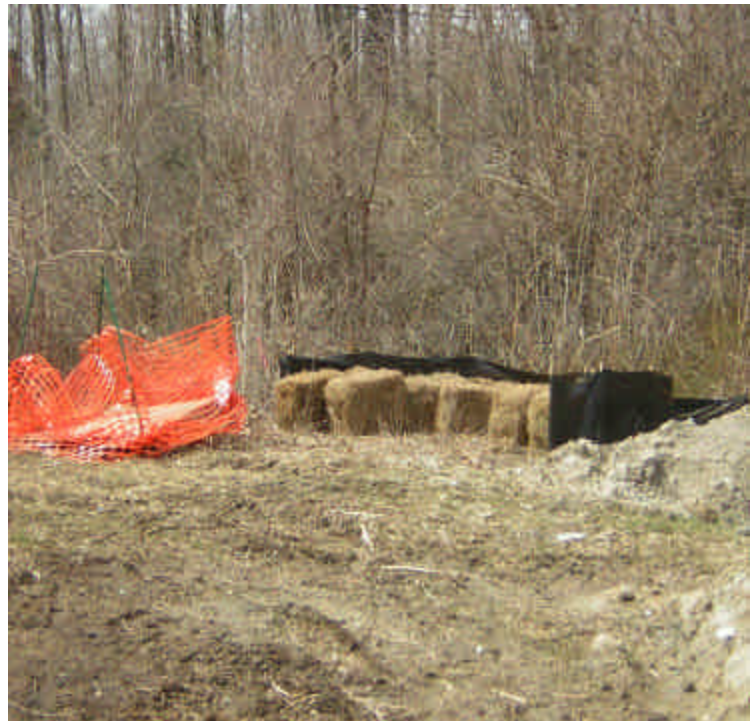
Areas of Inspection	Observation	Recommended Action	Corrective Action
Dewatering	<p>-Dewatering corrals had been constructed at structures 24 &amp; 25 located off Lime Kiln Road and John Todd Way. Corrals were placed directly upgradient of the wetland areas due to topography and limited workspace. No active dewatering was occurring during the inspection. 4/12/06.</p> <p>- No obvious dewatering efforts were noted at the remaining structures 4/12/06.</p> <p>-Watch areas of necessary dewatering in the Norwalk Section as many foundations are immediately adjacent to resource areas 4/12/06.</p>	<p>-Monitor the dewatering activities at structures #24 and 25 in order to avoid impacting the adjacent wetland areas. If corrals are not functioning properly an alternative method, such as filter bags, will need to be used immediately in these areas.</p> <p>- Release water to the ground only in well vegetated areas if it will not reach any resource areas. (Make sure to check downgradient for these areas) Otherwise use a filter bag or adequate containment. 3/9-4/6/06.</p>	<p>-N/A at this time</p> <p>-N/A at this time</p>

**(345kV H-Frame Lime Kiln Road) Both photos show a view of the work area at pole #25. Photo on the right shows the dewatering corral that was constructed adjacent to the wetland. Due to the limited workspace and size of the wetland there was little alternative for placement of the corral.**

**Dewatering activities will be monitored and alternative methods discussed if problems occur.**

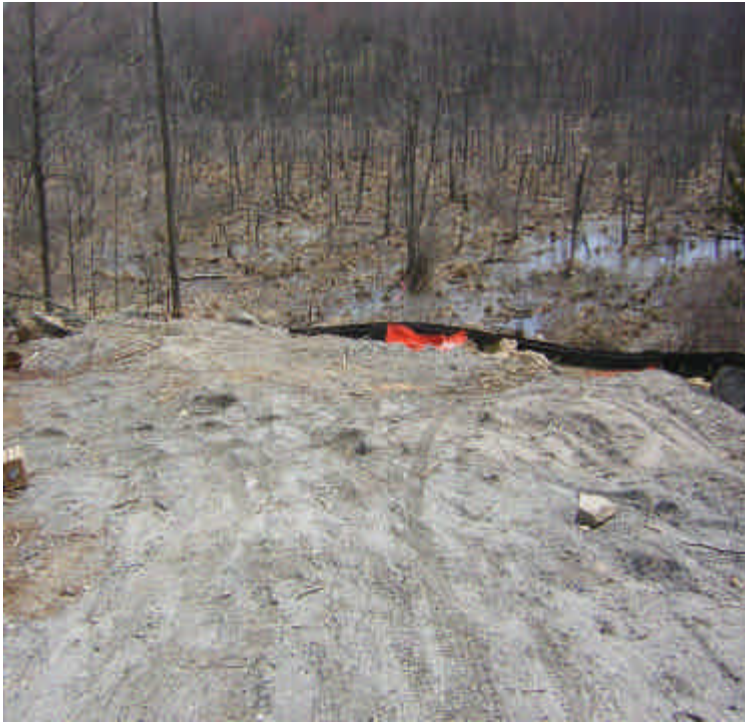
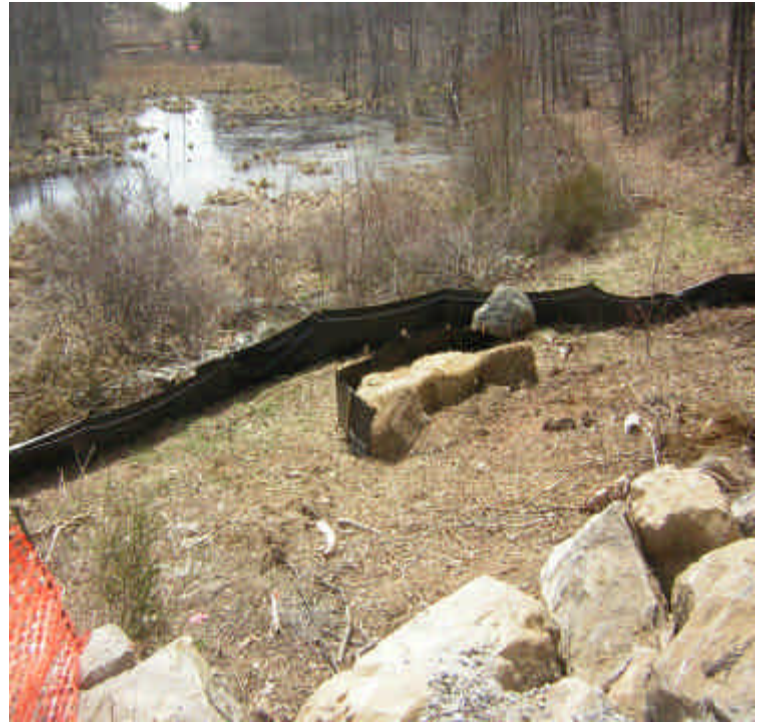
**(345kV H-Frame off John Todd Way) Both photos show a view of the work area near structure #24. Photo on the right shows the dewatering corral placed adjacent to the wetland. Due to the limited workspace and size of the wetland there was little alternative for placement of the corral. Dewatering activities will be monitored and alternative methods discussed if problems occur.**

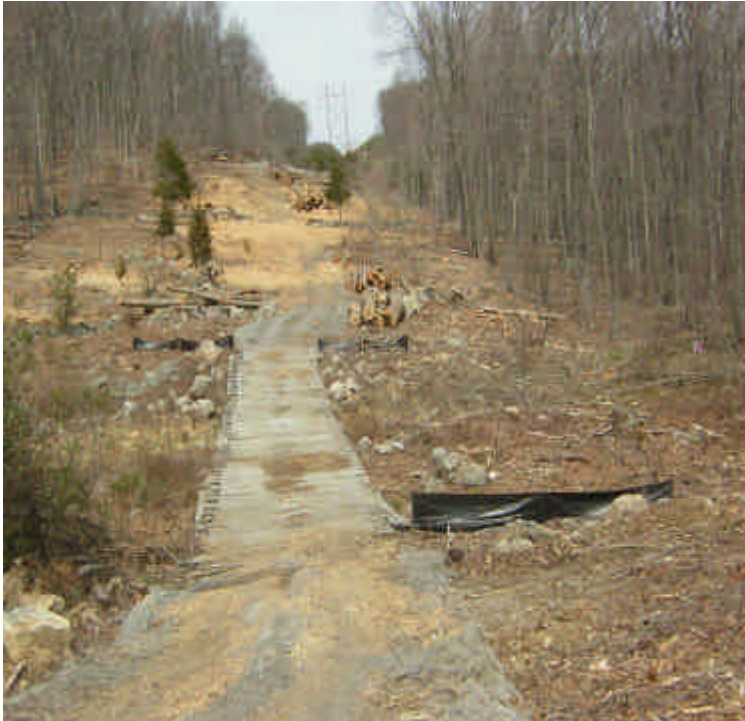
**(345kV H-Frame off Costa Lane and Norwalk Section) Photo on the left shows a view of the wetland crossing located in the vicinity of pole#29. Erosion controls are functioning well here. Photo on the right shows the ROW south of Broad St. where stone was placed. Check silt fence status prior to beginning work. 4/12/06**

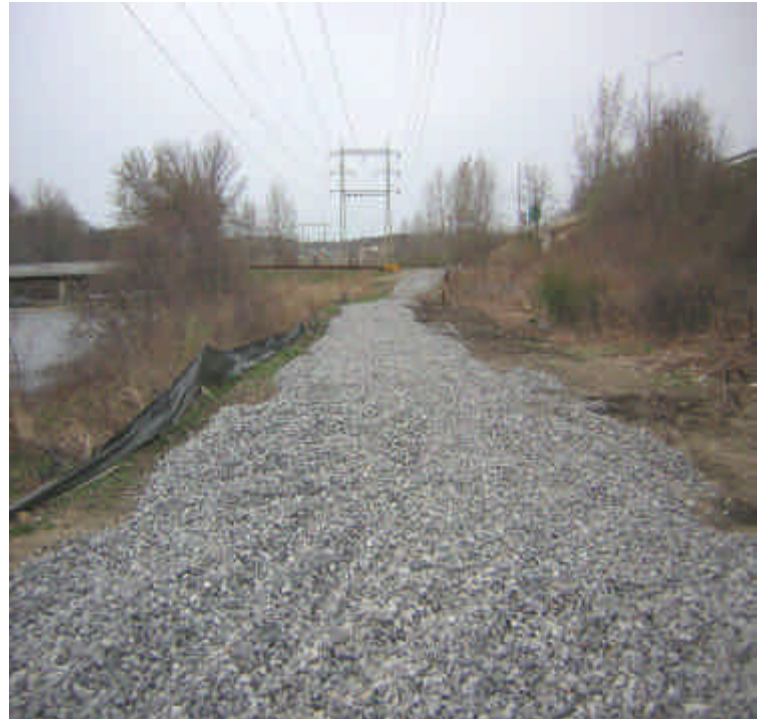
Areas of Inspection	Observation	Recommended Action	Corrective Action
	<p>- Stone was placed in the ROW to the south of Broad St. 4/12/06</p> <p>-Some work is also accessed off the cul-de-sac at April Lane. 4/12/06</p>	<p>4/12/06</p> <p>- None at this time. 4/12/06</p>	<p>- N/A</p> <p>-N/A</p>
<p>Foundation construction</p> <p><b>Composite</b></p> <p><b>345kV H-Frame</b></p>	<p>-The only current work in this section is related to clearing. 3/2-4/12/06.</p> <p>-Poles remain in place for installation in some locations along the Bethel Reservoir section. Wooden pole installation continues here. All poles except #1 are in place in the Chestnut Ridge section. 4/6-4/12/06.</p>	<p>-See erosion control and clearing sections. 4/12/06.</p> <p>- None at this time. 4/12/06.</p>	<p>-N/A</p> <p>-N/A</p>
<p><b>Norwalk Section</b></p>	<p>- Most poles are up in the Costa Lane section. Pole installation continues near John Todd Way. 4/6-4/12/06.</p> <p>-Foundation drilling and pouring continues to the north of Perry Ave. (off April Lane) as well as north of Broad St. 4/6-4/12/06.</p> <p>-Foundation drilling was also noted in the ROW west of Norwalk Junction. 4/12/06</p>	<p>-None at this time. 4/12/06</p> <p>-See dewatering and erosion controls section for more information. 4/6-4/12/06.</p> <p>-None at this time</p>	<p>-N/A</p> <p>-N/A</p> <p>-N/A</p>

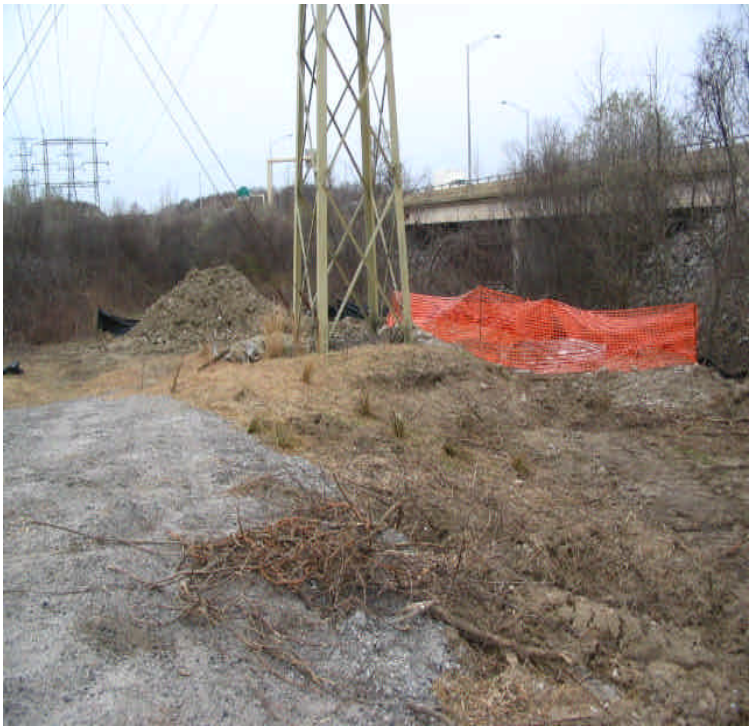
- Silt fence remained in place at several locations north of Broad St., including near the river. 4/12/06	- Continue to maintain fence due to its proximity to resource areas. 4/12/06	-N/A (silt fence installed proactively)

**(345kV H-Frame Norwalk Section) North of Broad St.: Photo on the left shows a foundation area where erosion controls are installed adjacent to the wetland. Photo on the right shows a pit dug potentially for washing out concrete. A liner should have been installed. 4/12/06**

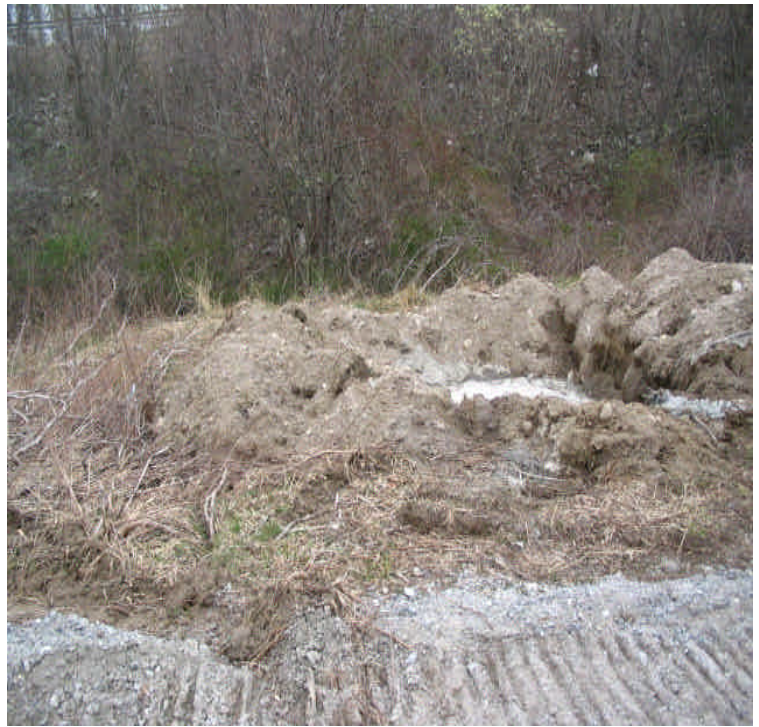
- Several spots of concrete were noted on the ground here but there	- Pick up the spills of hardened concrete and

Areas of Inspection	Observation	Recommended Action	Corrective Action
	<p>was also a dug pit which appeared to contain concrete. 4/12/06</p> <p>-Silt fence was installed at the foundation drilling near Norwalk Junction. 4/12/06</p>	<p>line any washout areas with plastic from now on. 4/12/06</p> <p>- Continue to maintain fence due to its proximity to resource areas and watch dewatering carefully. 4/12/06</p>	<p>-N/A (silt fence installed proactively)</p>
<p>Inland Wetland and Watercourse encroachment and mitigation</p> <p><b>Composite</b></p>	<p>-The D&amp;M plan approved stone on geotextile fabric at the wetland crossings have worked well. Efforts were made near Archers Lane to start removing some accumulated sediment. 4/6-4/12/06.</p> <p>- Direct damage was noted in the wetland at the 3<sup>rd</sup> crossing as a result of equipment slipping. 2/16-4/12/06.</p> <p>- Efforts were also being made near the 1<sup>st</sup> crossing to remove noticeable sediment deposits in the wetland. 4/6-4/12/06.</p> <p>- Use caution in clearing trees from wetland areas. Avoid creating ruts when skidding them out. Wood debris at the wetland near Gallows Hill will be left in place within the first ~30 feet from the wetland. 3/29-4/12/06.</p> <p>- Use caution in removing trees from wetland areas or adjacent to streams in this section as well. Avoid creating ruts when skidding them out. 1/19-4/12/06.</p> <p>-If a wetland is being</p>	<p>- As the access is considered temporary, the stone will be removed when final work ends so the wetlands can be restored. 1/26-4/12/06.</p> <p>- The damage to the 3<sup>rd</sup> wetland should be repaired. 4/12/06.</p> <p>- The crossing could also use some clean stone if necessary which may help reduce additional sediment deposits. 1/4-4/6-4/12/06.</p> <p>- Retain shrubs and low growth as much as possible. 3/2-4/6/06.</p> <p>- If damage is noted during the spring, the previously created ruts should be repaired if possible. 3/9/06-4/12/06.</p> <p>- Try to leave shrubs and low growth where possible, especially at stream buffers. 2/2-4/12/06.</p>	<p>-N/A until evaluated at the end of work.</p> <p>(Efforts are underway to remove accumulated sediment in some areas)</p> <p>-Efforts have been made to remove sediment.</p>

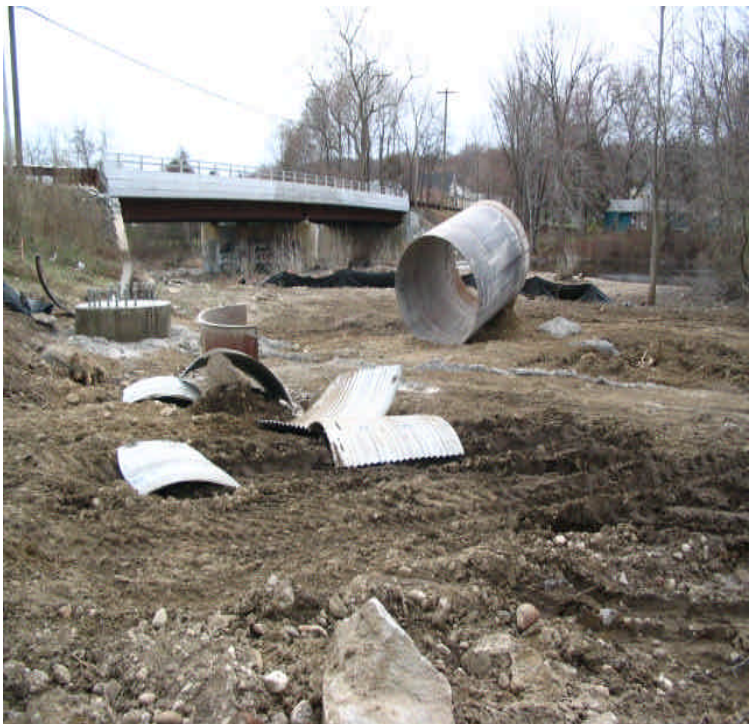
**Photo on the left shows a view of more foundation work, immediately north of Broad St. Erosion controls are in place by the river. Photo on the right shows one of several concrete washout spots that should be removed and controlled. 4/12/06**

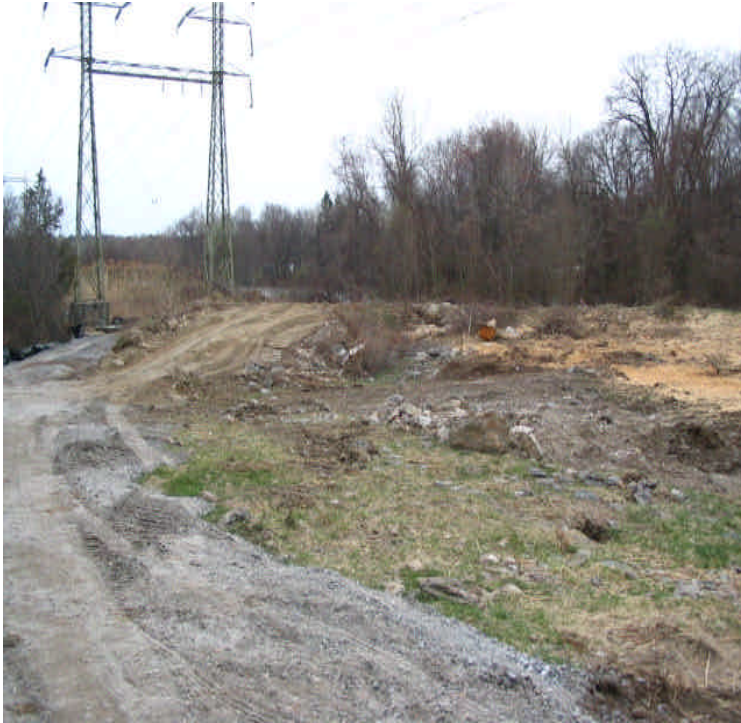
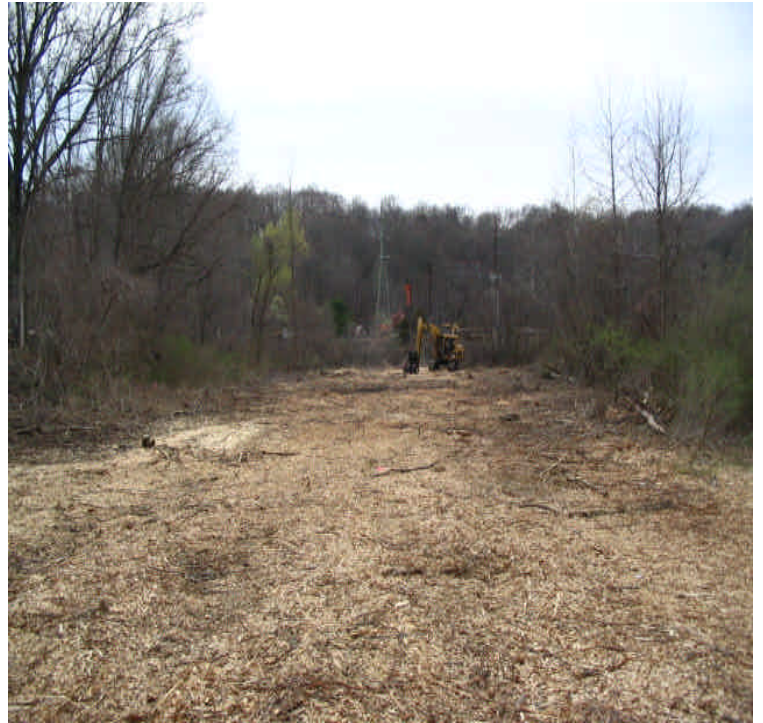
- Some clearing was noted to the north of Perry Ave. 4/12/06	- None at this time. 4/12/06.	
	-Clearing had occurred to create two corridors into Norwalk Junction. 4/12/06	- None at this time. 4/12/06	-N/A

**(345kV H-Frame Norwalk Section) Perry Ave and Norwalk Jct.: Photo on the left shows a view of the clearing and work north of Perry Ave. Photo on the right shows the clearing beyond the Norwalk River for one of the corridors into the transition station. 4/12/06**

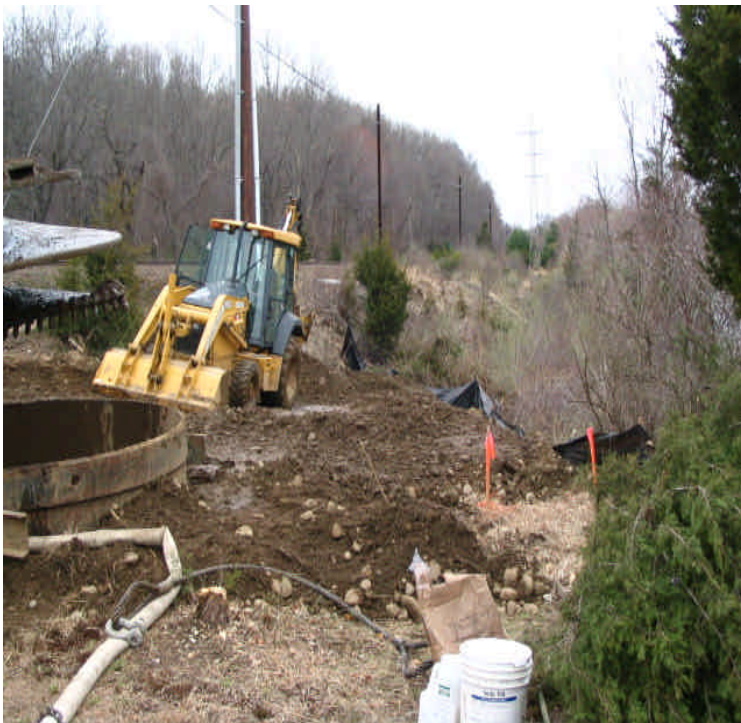
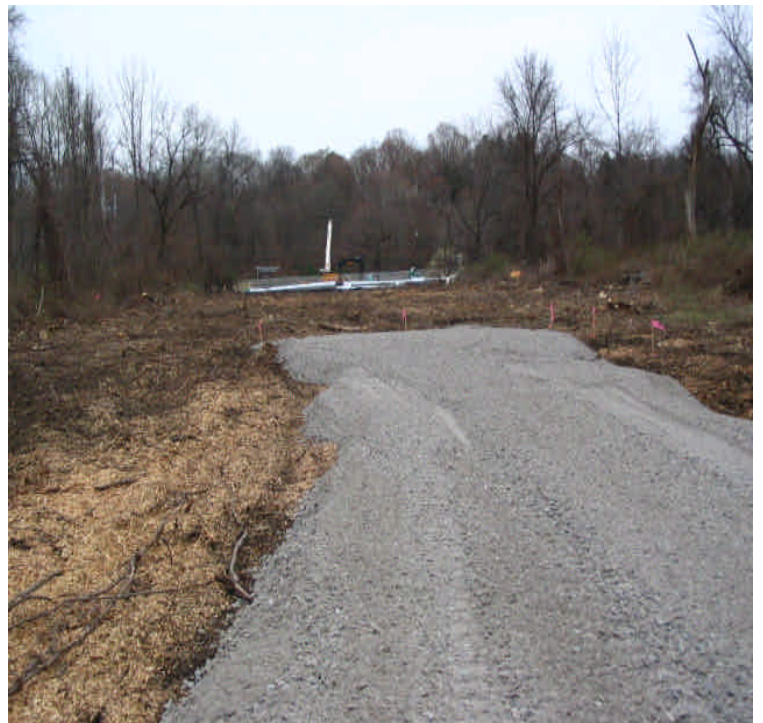
**Norwalk Jct Area: Photo on the left shows a view of foundation work adjacent to the ponded area. Erosion controls were up. Photo on the right shows the second cleared corridor into the transition station where stone was placed. 4/12/06**
